City of Everett ADA Transition Plan

July 2018

Department of Public Works

City of Everett
Department of Public Works (DPW)

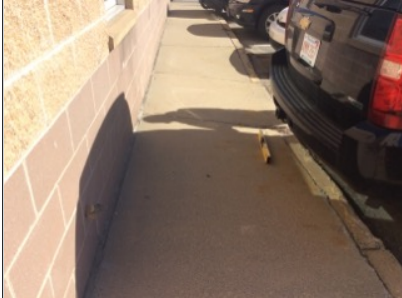
ID	Location	Floor	Room	Element	Type	Photo	Issues	Current Measure	Recommendations	Quantity	Price	Cost Estimation
Approach and Entrance												
Exterior Access Route												
1	Accessible Route From Parking Lot to Main Entrance	Ext.		Exterior Access Route	Walkway

Cross slope > 1:50 (2.00%)	10.5%	Reduce cross slope to be no steeper than 1:50 (2.00%).	1	90	\$90
Curb Ramp												
2	Main Entrance	Ext.		Curb Ramp	Blended Transition

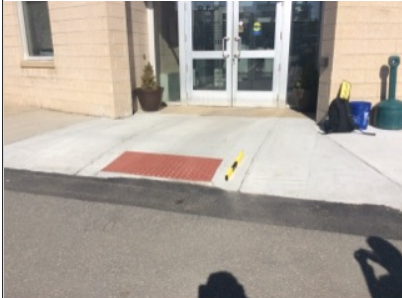
Running slope > 1:12 (8.33%)	15.8%	Reduce running slope to be no steeper than 1:12 (8.33%).	1	120	\$120
3	Parking Lot	Ext.		Curb Ramp	Parallel

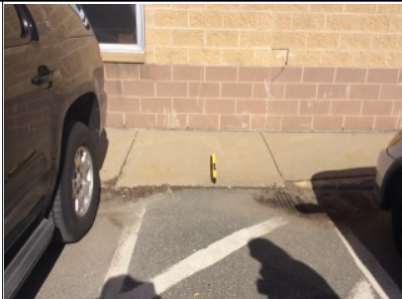
Landing not provided at top of curb ramp	-	Provide landing at top of curb ramp or reconfigure ramp.	1	1225	\$1225
Off-Street Parking Lot or Garage												
4	Parking Lot	Ext.		Off-Street Parking Lot or Garage	Visitor

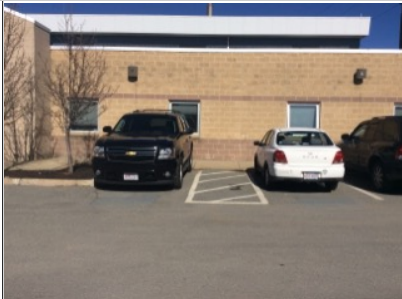
Total # of parking Total # of designated accessible parking spaces Total # of designated van accessible spaces Vehicle space < 96" wide at car space Sign not provided	58 3 0 89" -	Provide one van accessible and two car accessible spaces. Provide signage at both spaces. Ensure accessible space is at least 96" wide. Provide a sign with the bottom of the sign 60" min. above the ground and the top 96" max. above the ground.	1	1325	\$1325

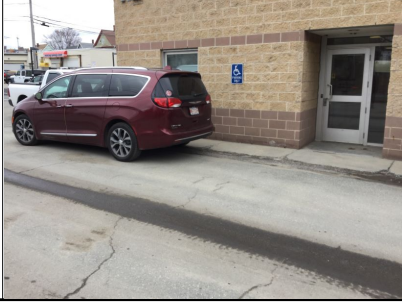
ID	Location	Floor	Room	Element	Type	Photo	Issues	Current Measure	Recommendations	Quantity	Price	Cost Estimation
5	Parking Lot	Ext.		Off-Street Parking Lot or Garage	Visitor

Access aisle not provided Sign < 60" above finished grade	- 55"	Provide a marked access aisle that is at least 60" wide./Provide a marked access aisle that is at least 96" wide. Locate sign with the bottom of the sign 60" above the ground.	1	150 Labor	\$150
Access to Goods and Services												
Doors, Doorways, & Gates												
6	Main Entrance	1		Doors, Doorways, & Gates	Circulation

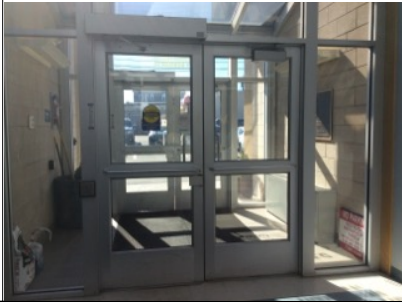
Automatic door opener not operable	-	Repair or replace the door opener.	2	1530	\$3060
Signage												
7	Staff Break Room (Used for Voting)	1		Signage	Designation

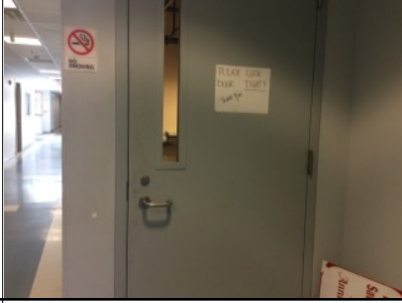
Not provided Raised characters not provided Braille not provided	- - -	Locate signage alongside the door on the latch side. Provide text with raised characters duplicated in braille.	1	116	\$116

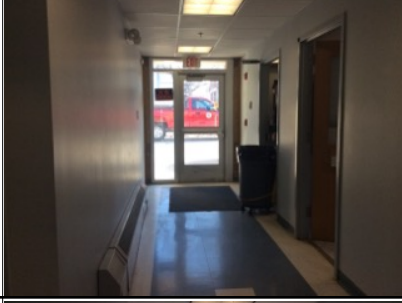
8	Emergency Exit by Staff Break Room	1		Signage	Egress

Raised characters not provided Braille not provided	- -	Provide text with raised characters duplicated in braille.	1	116	\$116
9	Exit to Parking Lot from End of Main Hallway	1		Signage	Egress

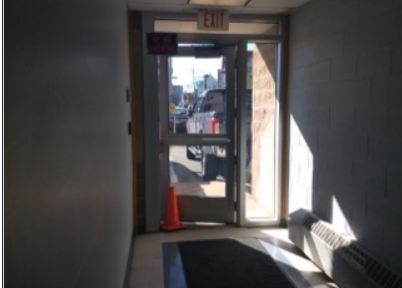
Raised characters not provided Braille not provided	- -	Provide text with raised characters duplicated in braille.	1	116	\$116

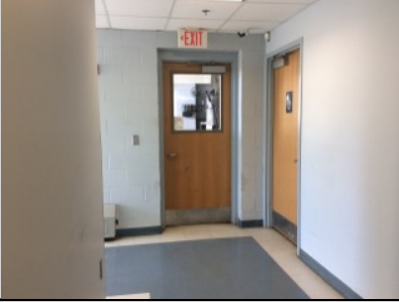
ID	Location	Floor	Room	Element	Type	Photo	Issues	Current Measure	Recommendations	Quantity	Price	Cost Estimation
10	Path to Emergency Exit	1		Signage	Egress

Raised characters not provided Braille not provided	- -	Provide text with raised characters duplicated in braille.	1	116	\$116
Service Counter												
11	Welcome Desk	1		Service Counter	N/A

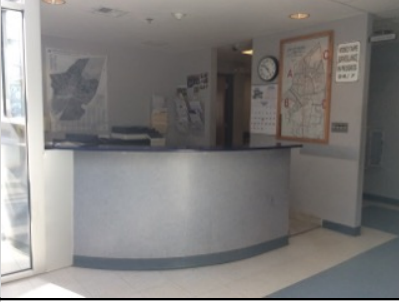
Counter > 36" high	41"	Provide a counter that is 36" max. above the ground or finish floor.	1	440	\$440
12	Main Entrance	1		Service Counter	N/A

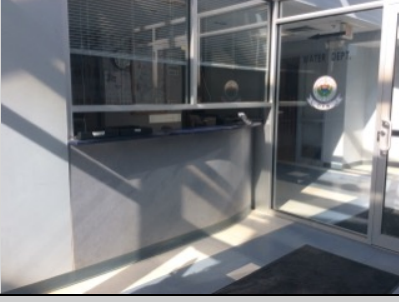
Counter > 36" high	41"	Provide a counter that is 36" max. above the ground or finish floor.	1	440	\$440
Operable Parts												
13	Main Entrance	1		Operable Parts	Equipment

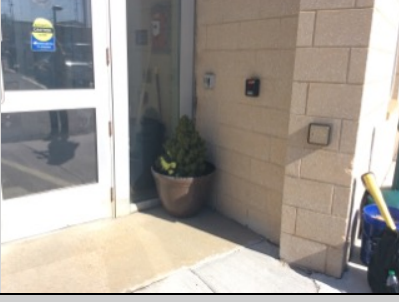
Clear floor space not provided	-	Relocate plants to provide a 30" by 48" clear floor space positioned for a forward approach at call button. Relocate plant.	1	Labor	\$0
Picnic Tables												
14	Main Entrance	Ext.		Picnic Tables	N/A

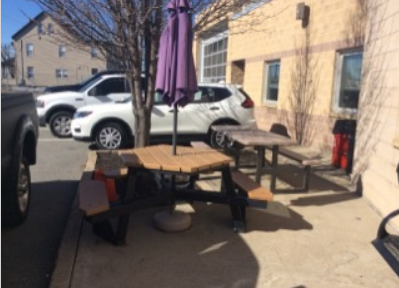
Number of seating spaces at picnic tables Number of accessible seating spaces Toe or knee clearance at tables not provided	7 0 25"	Provide at least 1 dining surface with toe and knee clearance.	1	700	\$700

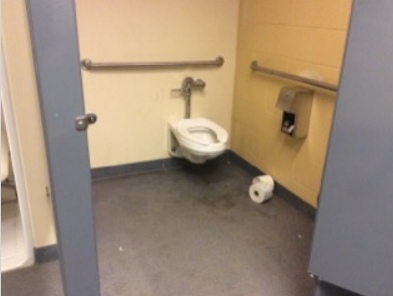
Door has malfunctioning self-closing hinge	-	Repair hinge.	1	Labor	\$0
16	Men's Toilet Room	1		Toilet Compartment	Accessible Compartment

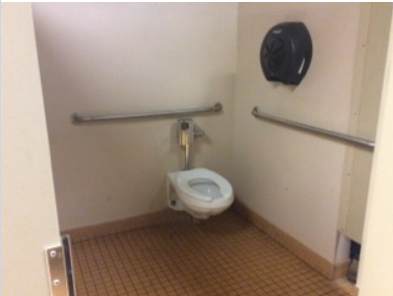
Non-compliant toilet paper dispenser	-	Relocate toilet paper so that it is 15" min high, located under the grab bar, and between 7" and 9" from the front of the toilet. Replace dispenser if it does not allow continuous paper flow.	1	353	\$353
Dispensers												
17	Men's Toilet Room	1		Dispensers	Soap Dispenser

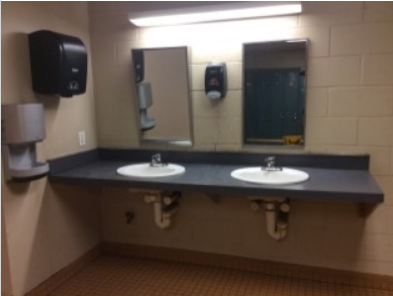
Controls > 42" high	53"	Relocate so the operable part of the soap dispenser is 42" max. above the finish floor.	1	353	\$353
18	Men's Toilet Room	1		Dispensers	Paper Towel Dispenser

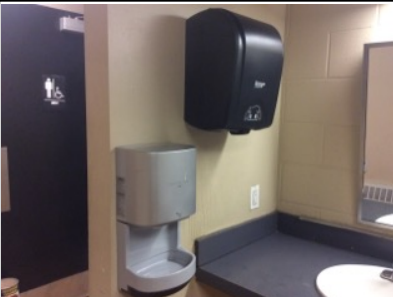
Controls > 42" high	55"	Relocate so the control of the paper towel dispenser is 42" max. above the finish floor.	1	353	\$353

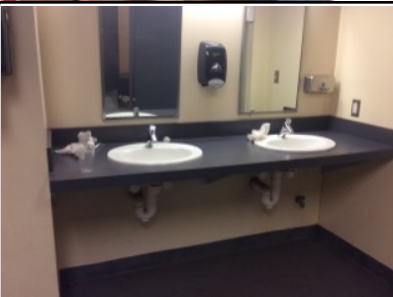
19	Women's Toilet Room	1		Dispensers	Soap Dispenser

Controls > 42" high	47"	Relocate so the operable part of the soap dispenser is 42" max. above the finish floor.	1	353	\$353

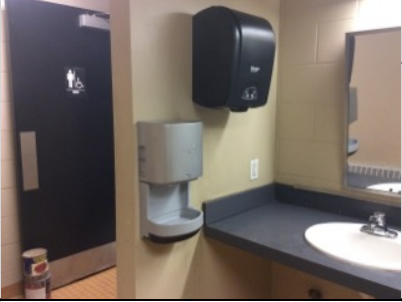
ID	Location	Floor	Room	Element	Type	Photo	Issues	Current Measure	Recommendations	Quantity	Price	Cost Estimation
20	Men's Toilet Room	1		Dispensers	Hand Dryer

Controls > 42" high Dispenser acts as a protruding object	43" 6"	Relocate so the control of the hand dryer is 42" max. above the finish floor and out of the circulation path.	1	353	\$353
21	Women's Toilet Room	1		Dispensers	Paper Towel Dispenser

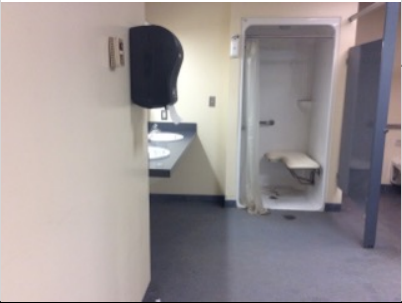
Controls > 42" high Dispenser acts as a protruding object	50" 10"	Relocate so the control of the paper towel dispenser is 42" max. above the finish floor and out of the circulation path.	1	353	\$353
Shower Compartment												
22	Women's Toilet Room	1		Shower Compartment	Transfer Type

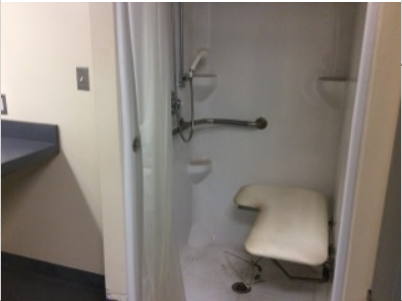
Clear floor space not provided at shower Size of shower compartment non compliant Seat is not between 17"- 19" high	34" deep 20"	If this shower is used by the public it should be brought into compliance. (Provide a 48" x 36" clear floor space for a transfer shower, measuring 48" back from the control wall. Provide a transfer shower that is 36" by 36". Mount seat between 17"- 19" above the finish floor.)	1	-	\$0
